Quality Assurance and Source Inspection

Contract #: 04-0120F4Cty: SF/ALA Rte: 80 PM: 13.2/13.9File #: 69.28**WELDING INSPECTION REPORT****Resident Engineer:**Pursell, Gary**Address:** 333 Burma Road**City:** Oakland, CA 94607**Report No:** WIR-015533**Date Inspected:** 08-Jul-2010**Project Name:** SAS Superstructure**OSM Arrival Time:** 700**Prime Contractor:** American Bridge/Fluor Enterprises, a JV**OSM Departure Time:** 1900**Contractor:** Zhenhua Port Machinery Company, Ltd (ZPMC), Changxing Island **Location:** Shanghai, China

TOWER JETTY**MEASUREMENTS ON VERTICAL TRIAL ASSEMBLY SOUTH TOWER LIFT-2&3**

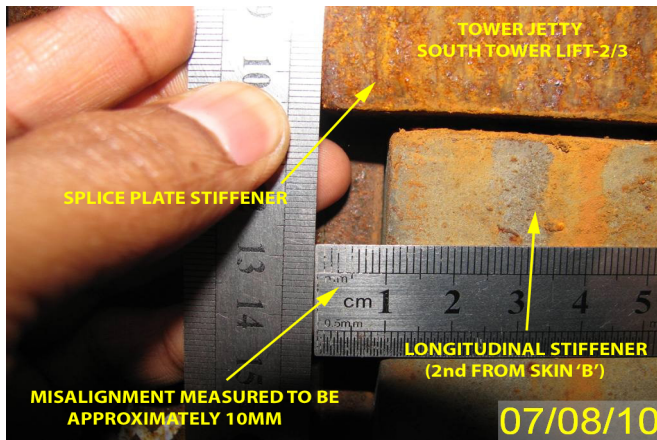
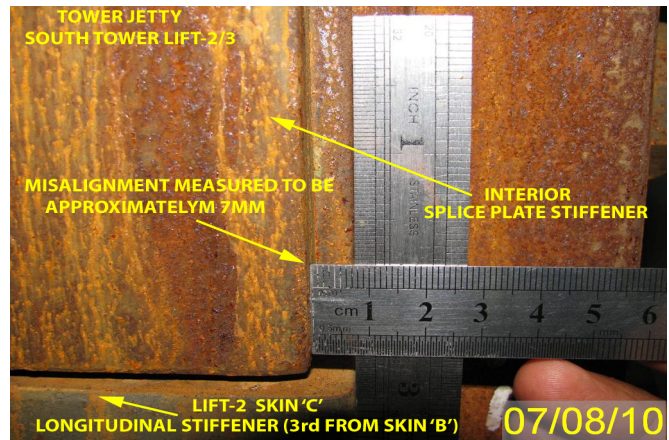
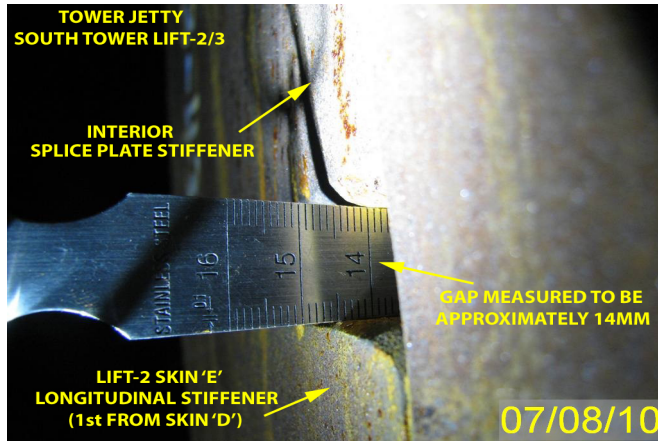
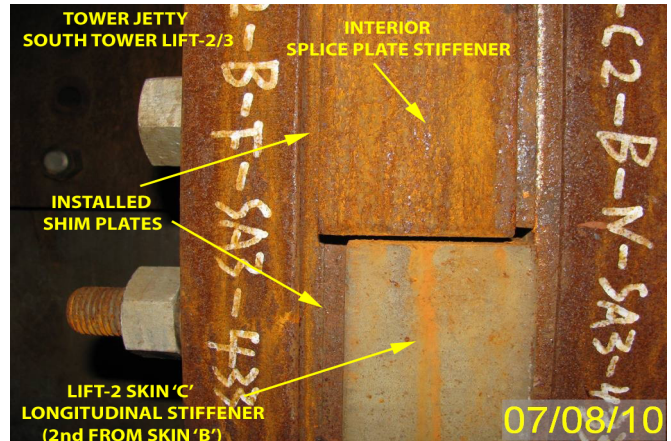
During the dimensional verification of Longitudinal stiffener (Skin) assembly with the Splice plate stiffener of south tower lift-2/3, this Quality Assurance Inspector (QA) discovered the following issue:

- At the lower end of the splice plate stiffeners to longitudinal stiffeners, Misalignment and Gap were found more than the permissible limit as per the contract documents.
- Lift-2 Skin 'C' 1st longitudinal stiffener (From skin 'B') Misalignment – 5mm
- Lift-2 Skin 'C' 2nd longitudinal stiffener (From skin 'B') Misalignment – 10mm
- Lift-2 Skin 'C' 3rd longitudinal stiffener (From skin 'B') Misalignment – 7mm

- Lift-2 Skin 'E' 1st longitudinal stiffener (From skin 'D') Gap – 14.5mm
